THE CALIFORNIA EARTHQUAKE OF APRIL 18, 1906

STATE EARTHQUAKE INVESTIGATION COMMISSION

IN TWO VOLUMES AND ATLAS

ANDREW C. LAWSON, CHAIRMAN

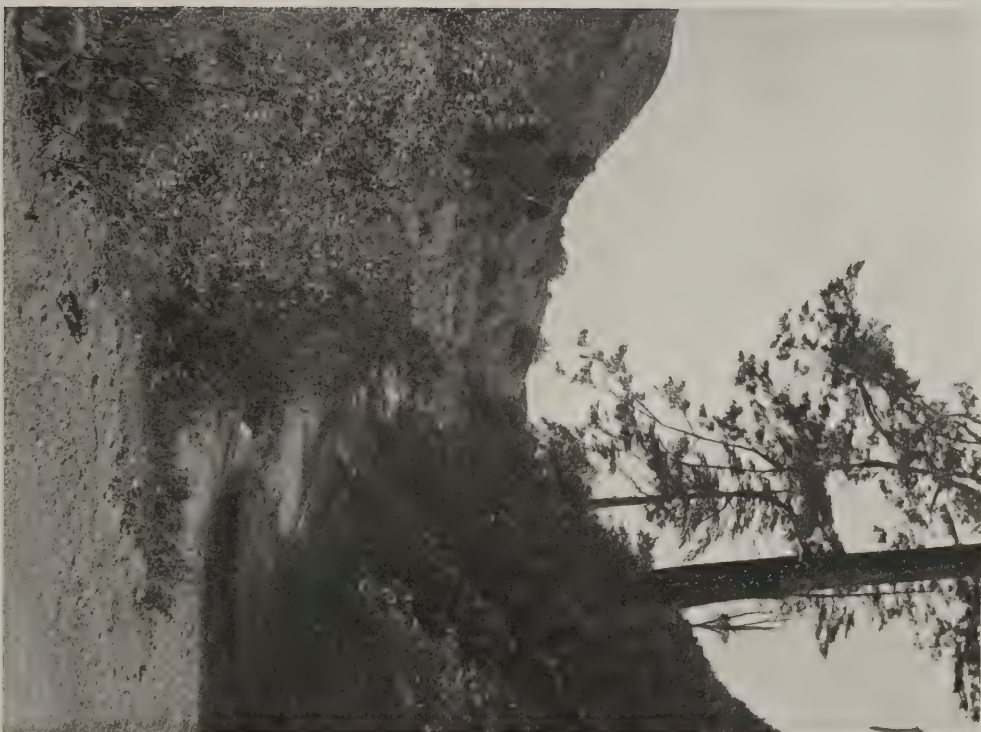
A. Wood Gulch, Humboldt County. The Rift near its northern end. A.S.E.

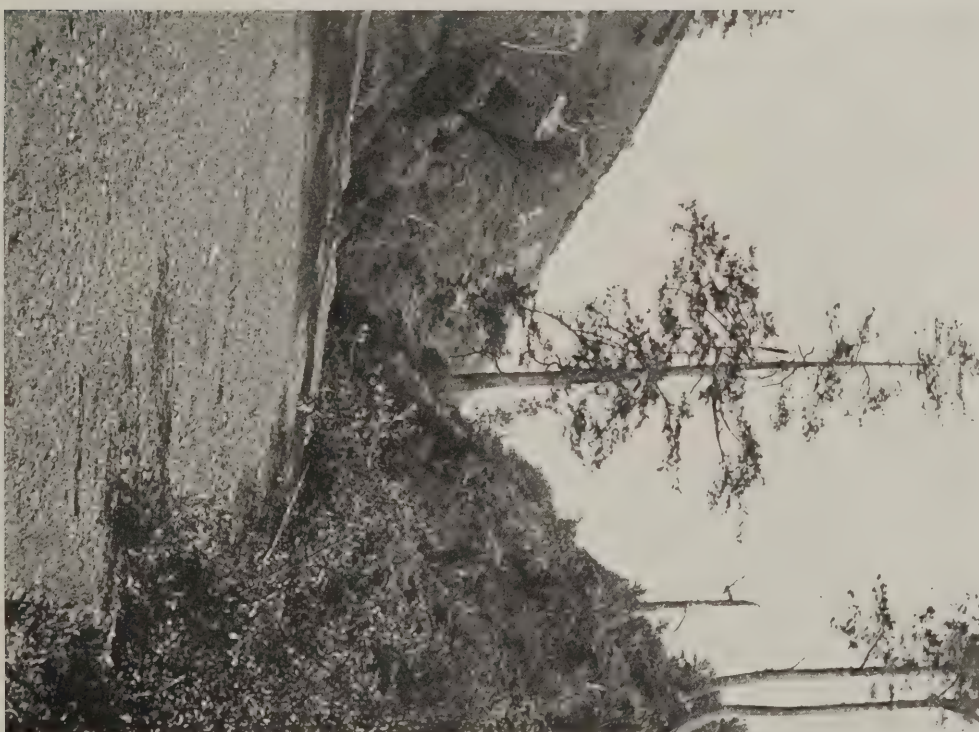
B. Another view of the Rift. Wood Gulch. A.S.E.

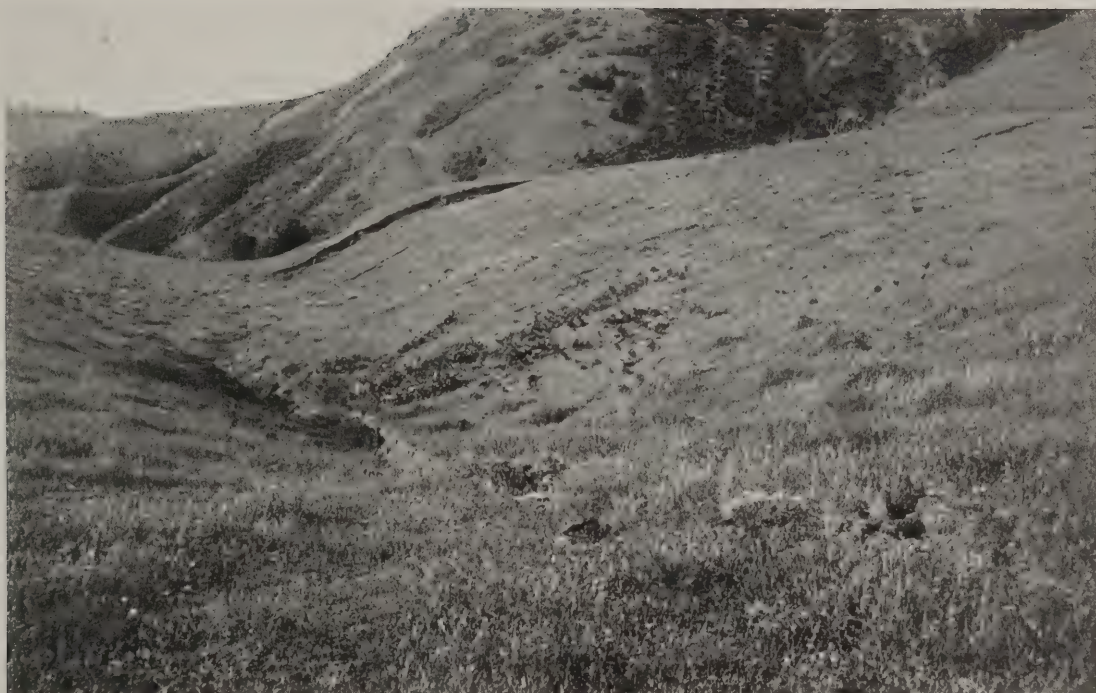
A. The Rift above Shelter Cove, Humboldt County. A. S. E.

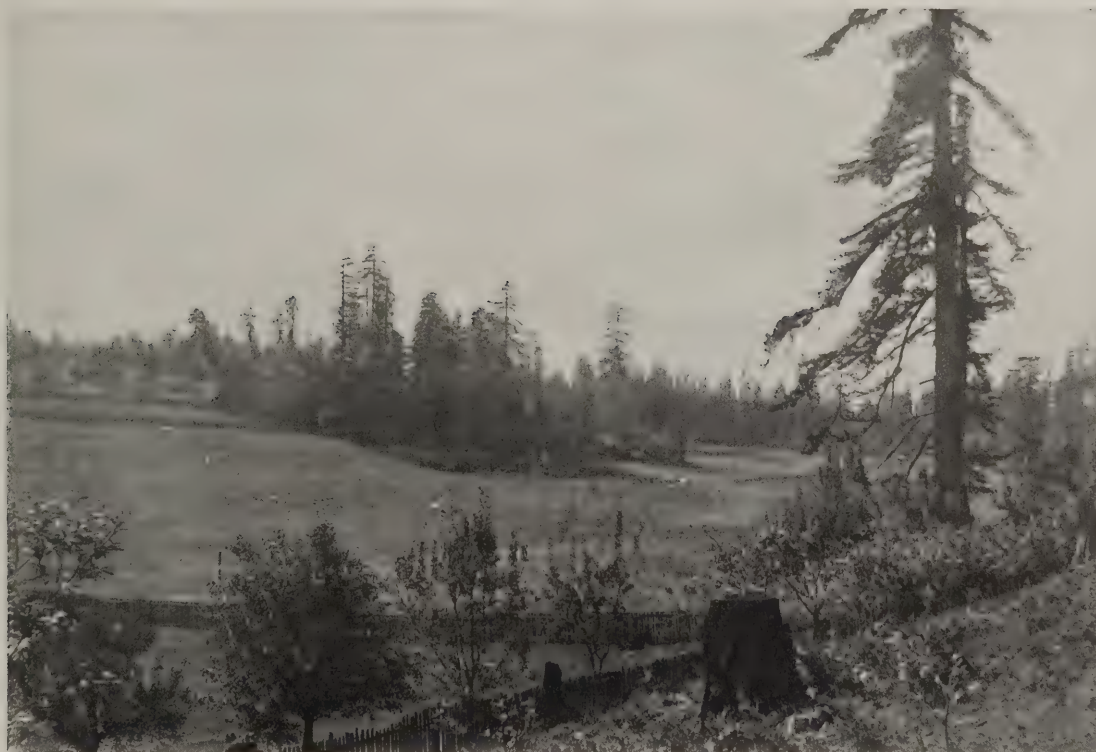
B. The Rift on the divide between the upper Gualala and the coast north of Fort Ross. H. W. F.

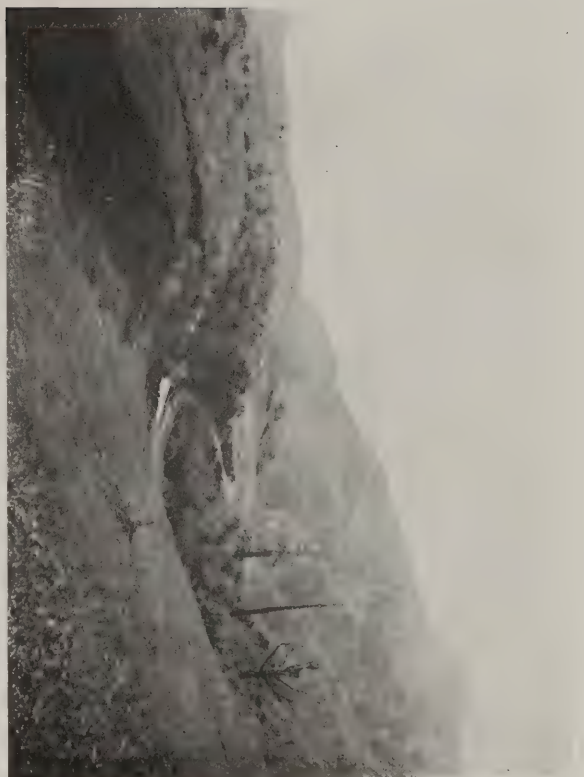
A. The Rift above Shelter Cove, looking northwest. The fault-trace follows old diastrophic features. F. E. M.

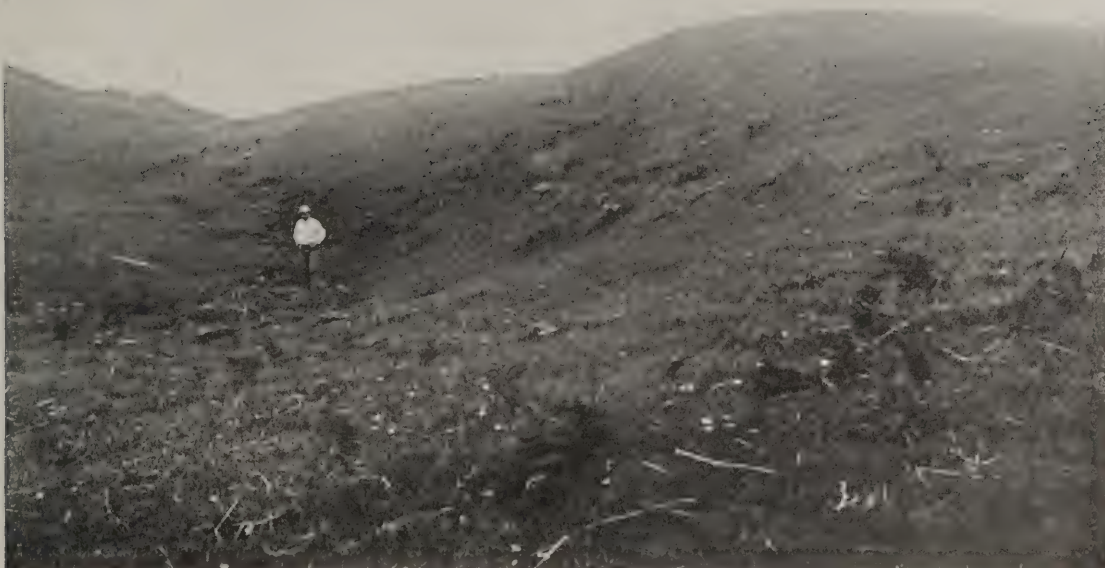
A. Characteristic Rift features southeast of Fort Ross. Figure on fault-trace. A. C. L.

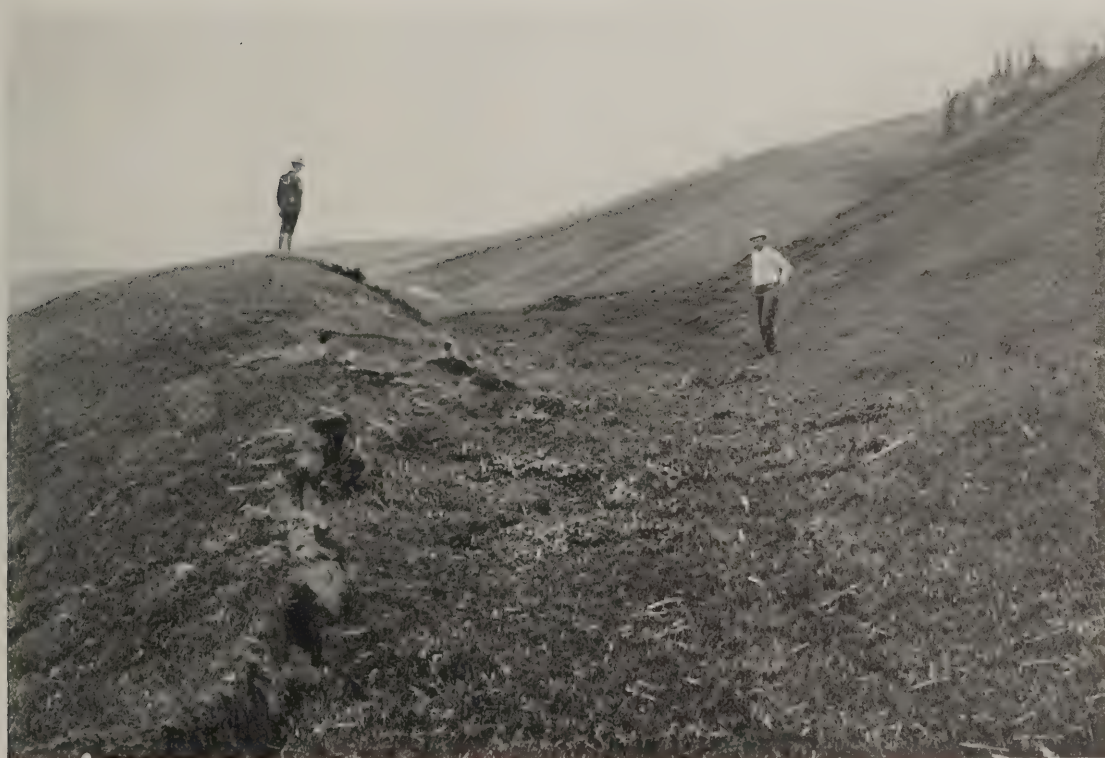
B. Characteristic Rift features southeast of Fort Ross. Fault-trace in foreground. A. C. L.

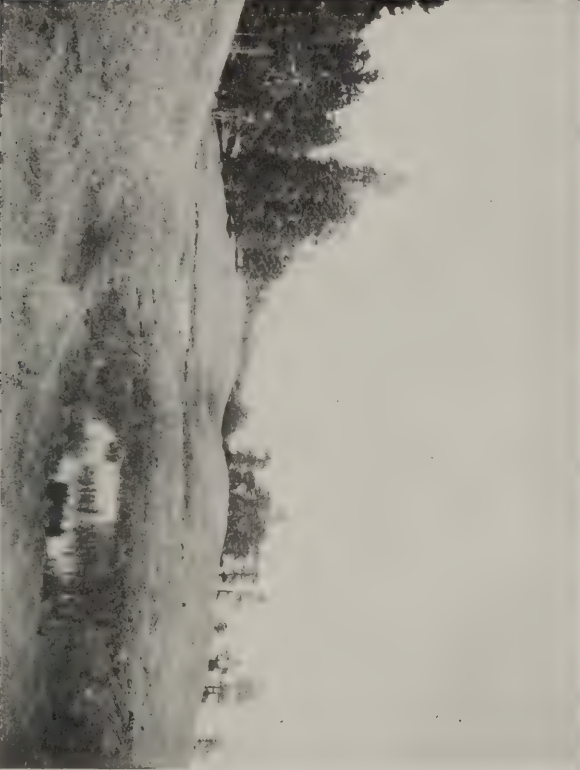
Characteristic Rift features near Fort Ross. Old scarps accentuated by new fault. Undrained ponds. F. E. M.

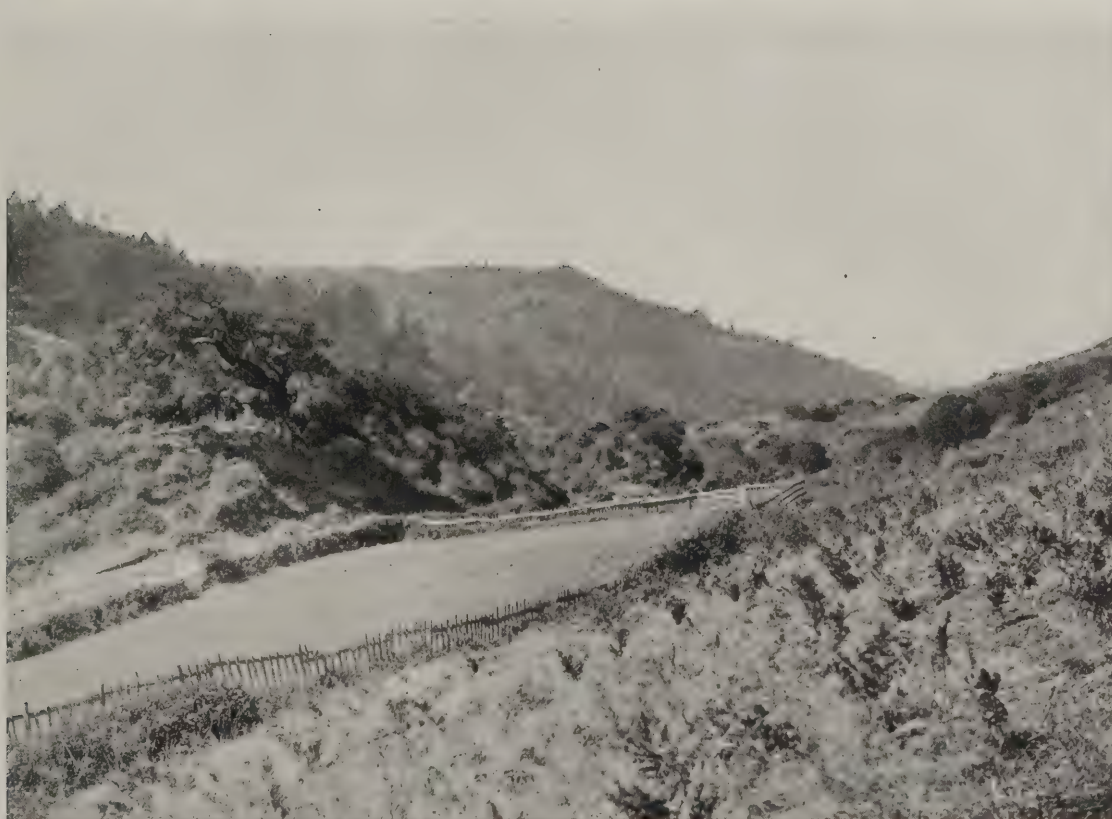
B. Fault-sag and side-hill ridge near Bondietti's ranch. The fault-trace follows sag and appears at left of field. G. K. G.

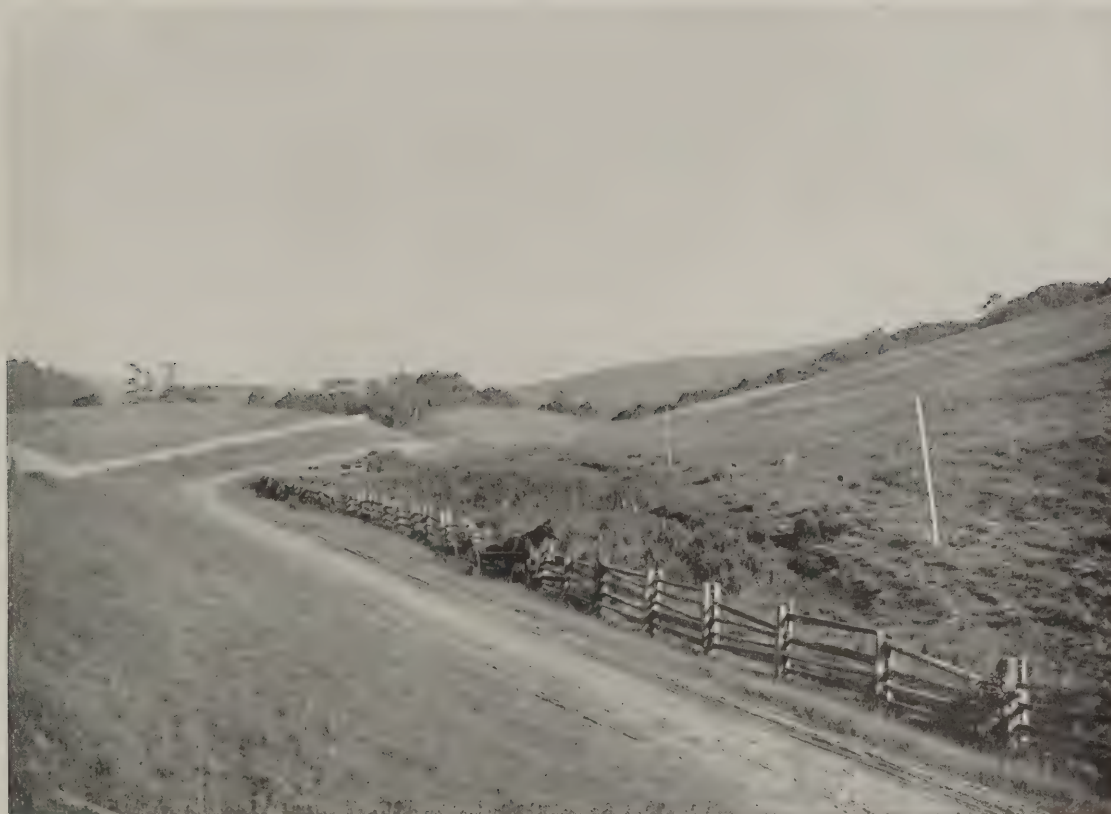
A. Fault-sag 6 miles south of Olema, looking northwest. The drainage crosses the sag from right to left. G.K.G.

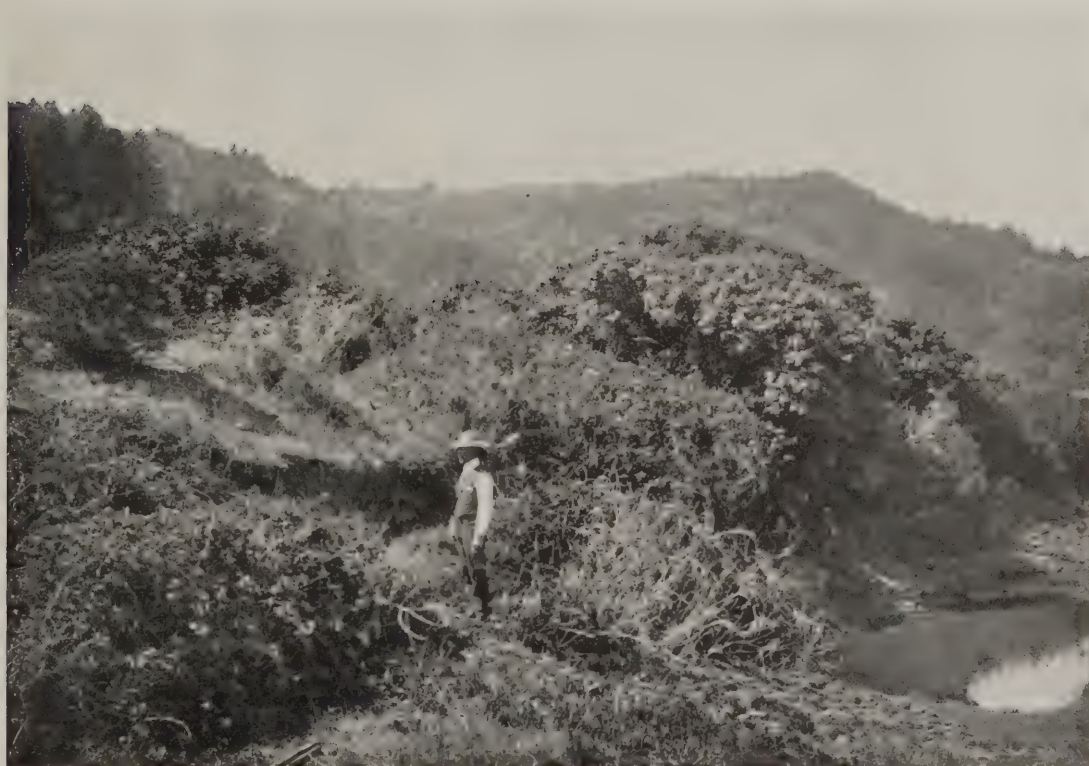
B. The fault-trace near Bondiotti's ranch, looking west. Illustrates the association of vertical displacement with fault-sags and ponds. G. K. G.

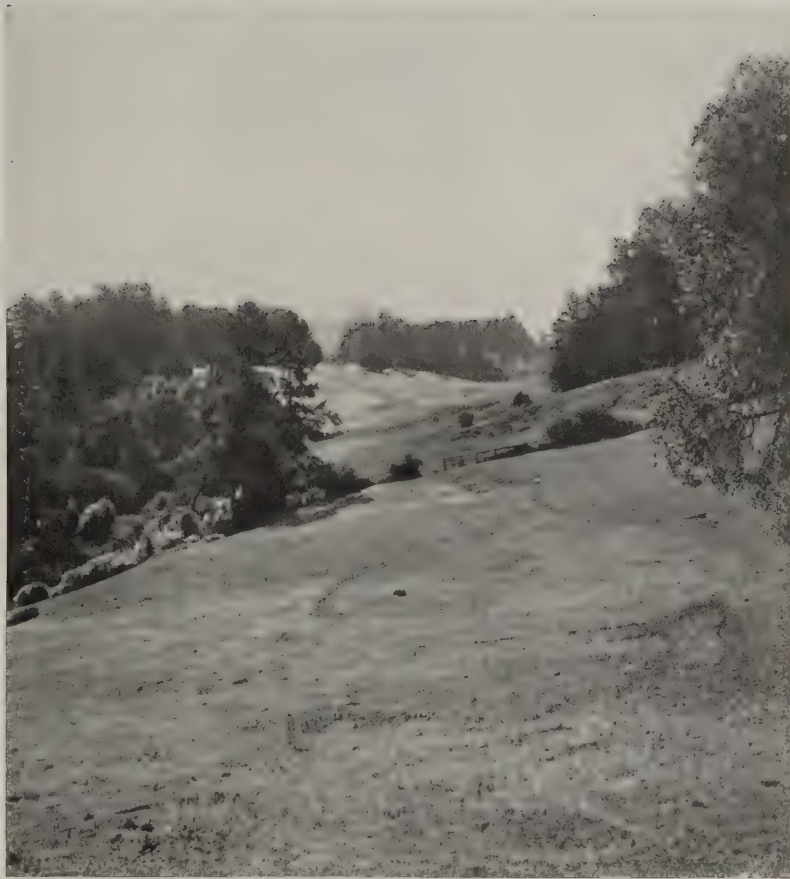
A. Fault-sag 2 miles south of Olema, looking southeast. G. K. G.

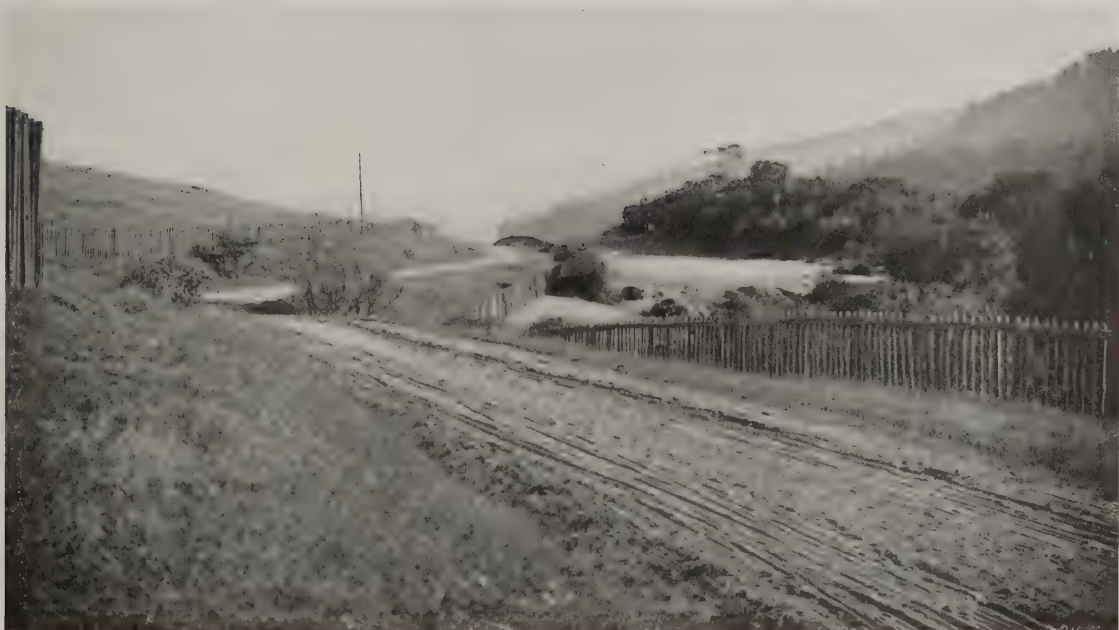
B. Fault-sag 3 miles south of Olema, looking southeast. G. K. G.

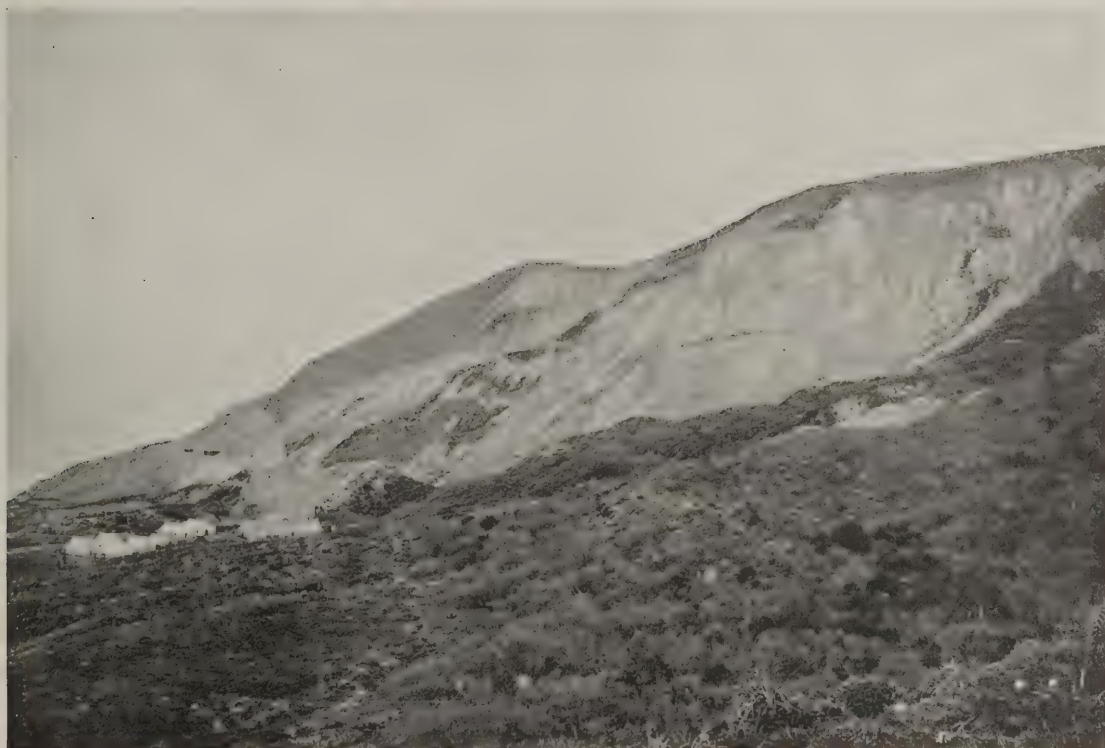
B. Looking northwest along the Rift. The landslide is just beyond the house. H. O. W.

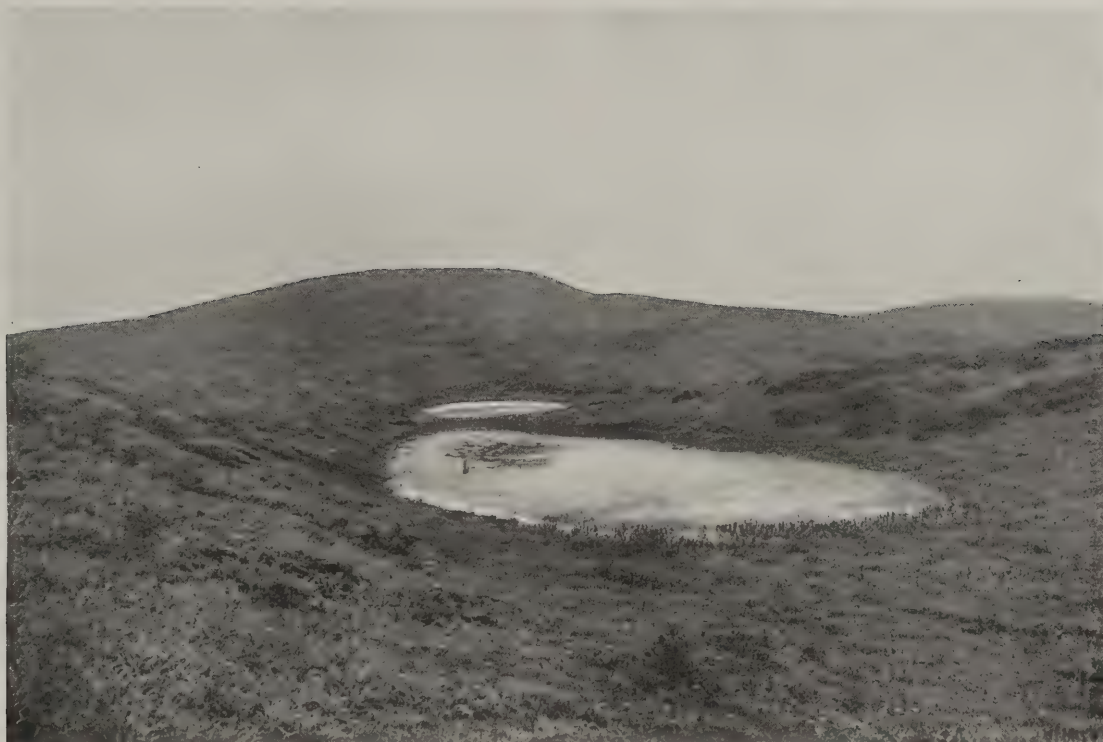
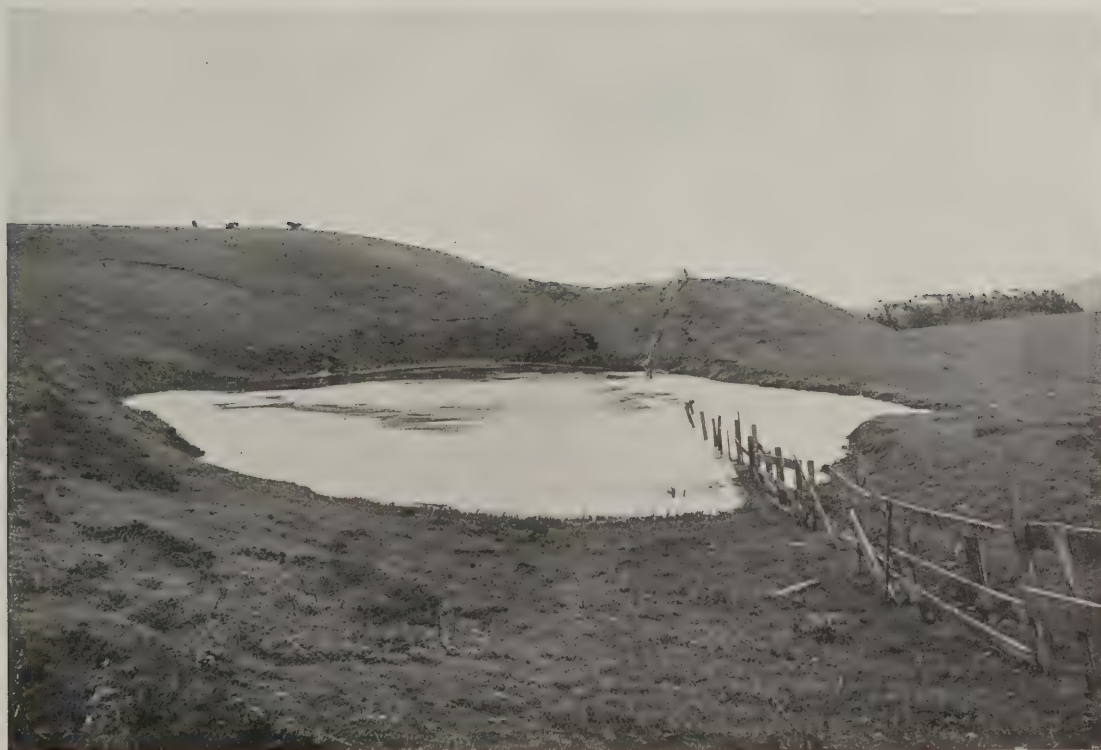
Characteristic ponds along the Rift southeast of Mussel Rock. H. O. W.

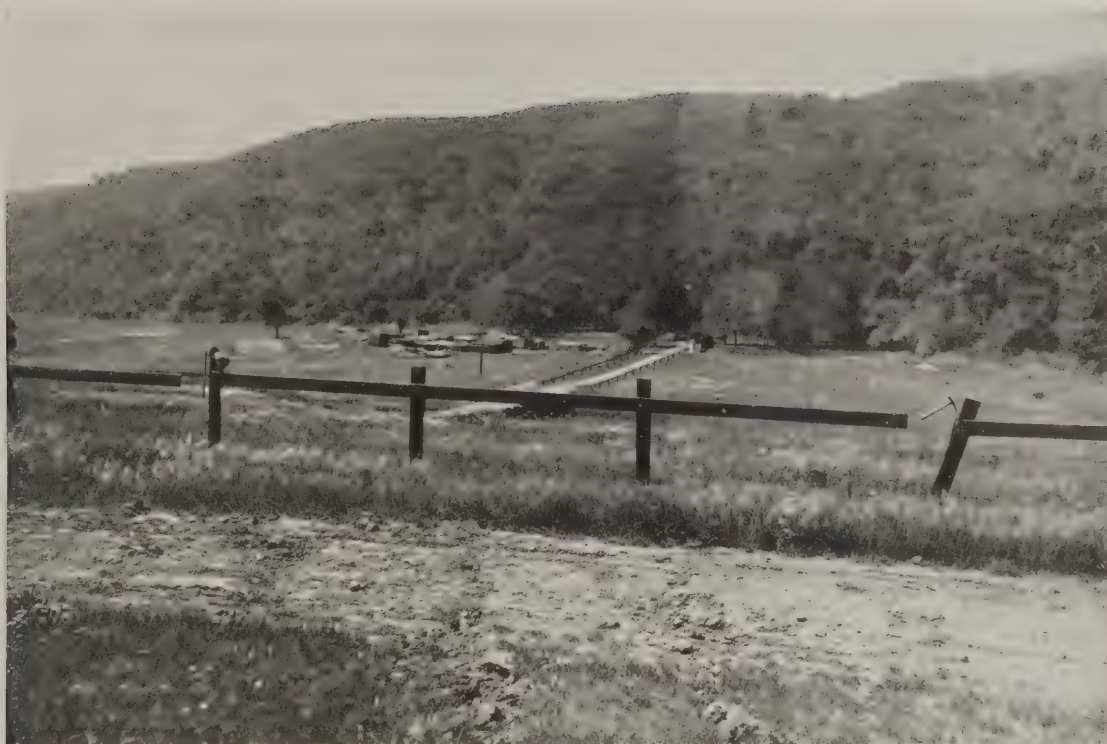
A. The Rift valley between San Andreas Lake and Crystal Springs, looking southwest. Fault-trace parallel to fence about 50 feet beyond. Auxiliary cracks in the foreground at an angle of 40° with it. J. C. B.

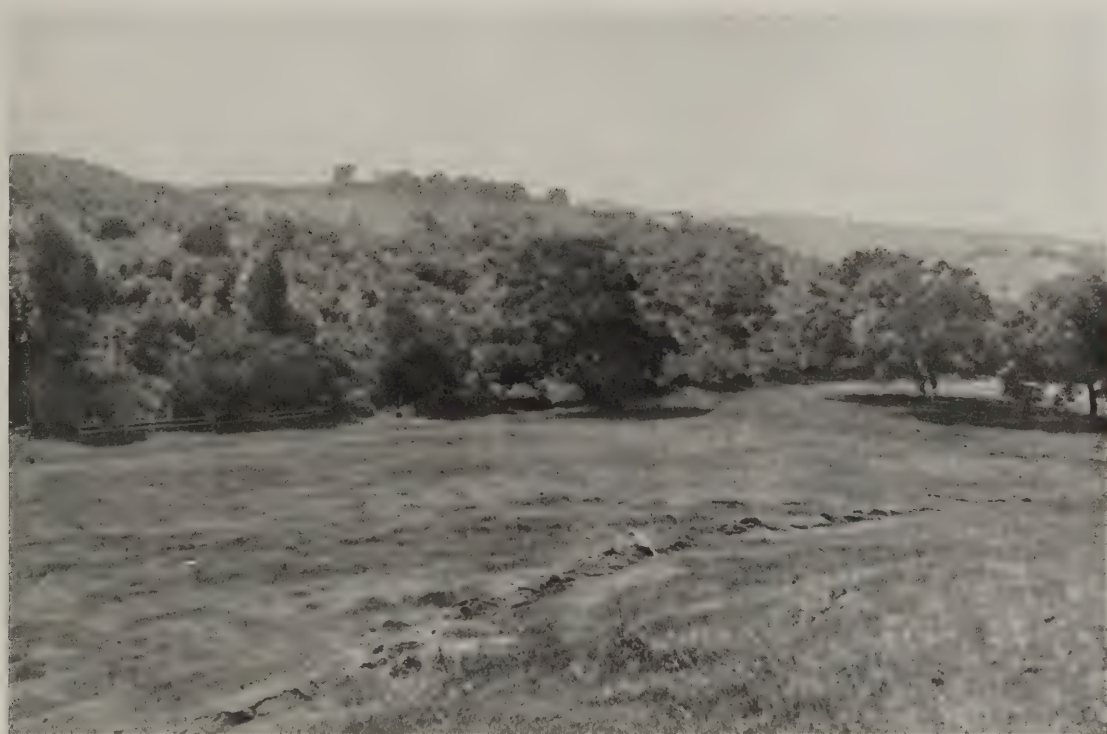
B. The Rift valley 5 miles west of Stanford University. Fault-trace in foreground. Per J. C. B.

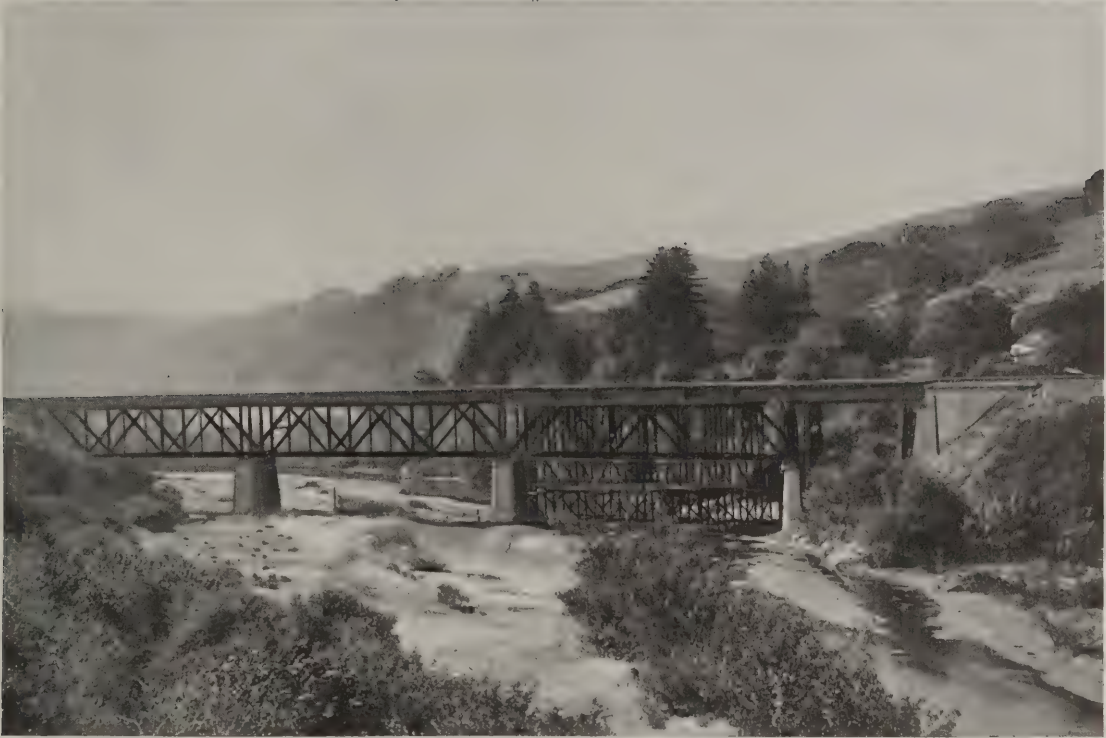
The earthquake of April 18, 1906, opened and displaced the walls of the old fault along the Rift as far south as the town of San Juan in San Benito County. The fault-trace passes directly under the western span of the Southern Pacific Railroad bridge across San Juan River, as shown by the displacement of the piers at the end of the bridge, a distance of 3.5 feet. For a distance of nearly half a mile on either side of the bridge, the river has established itself in the Rift. To the northwest the steep slopes of Mount Pajaro facing the canyon do not show any regular fissure. This does not, however, indicate any discontinuity in the fault, for the surface of the whole mountain is more or less broken by auxiliary cracks, secondary fissures, and slides.

A. The Rift followed by the Pajaro River at Chittenden. Dislocated bridge supported by false work. H. W. F.

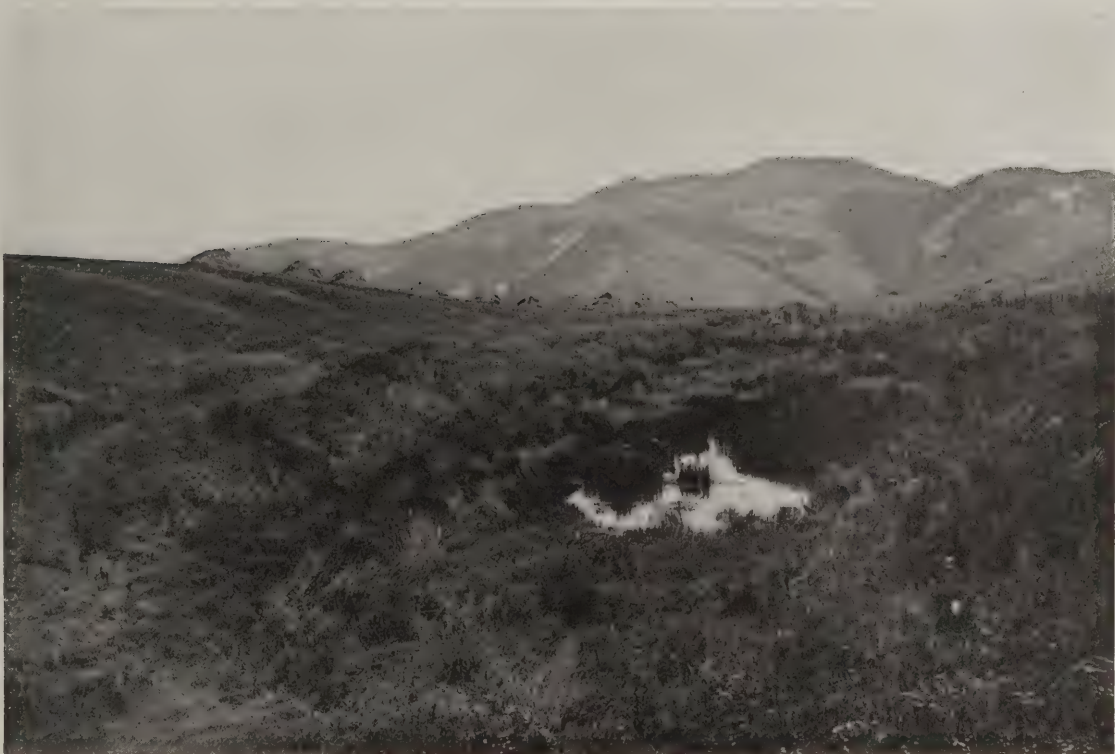
Southeast over the hills from the point where the Rift leaves the river, the characteristic features of the Rift make their appearance. It is marked by a small pond (plate 17B), springs, and a more or less continuous ridge with its steeper face toward the southwest. The fissure of the recent earthquake follows this series of features (plate 18A), and, at a point halfway between the bridge and San Juan, there is shown in a broken fence a horizontal displacement of 4 feet. A mile before reaching San Juan, granitic rocks are exposed upon the southwest side of the Rift. Shortly beyond this point the Rift leaves the hills and traverses the western edge of the valley of the San Benito River. The ridge which we have been following is now lost in the level floor of the valley, but as far as traceable its course is directly toward the low bluff upon the eastern edge of the town of San Juan. The fissure of the recent earthquake is to be seen where it crosses the road 0.5 mile northwest of San Juan, but has not been noted farther along the old Rift line. It appears to bend more easterly, and this probably connects it with the disturbances of the earth between Hollister and San Juan. Mr. Abbe, of San Juan, states that the earthquake of 1890 opened the old Rift and that the displacement of the walls, tho small, was in the same direction as in the recent earthquake.

B. The Rift a mile southeast of Chittenden. Pond on upper slope of hill. H. W. F.

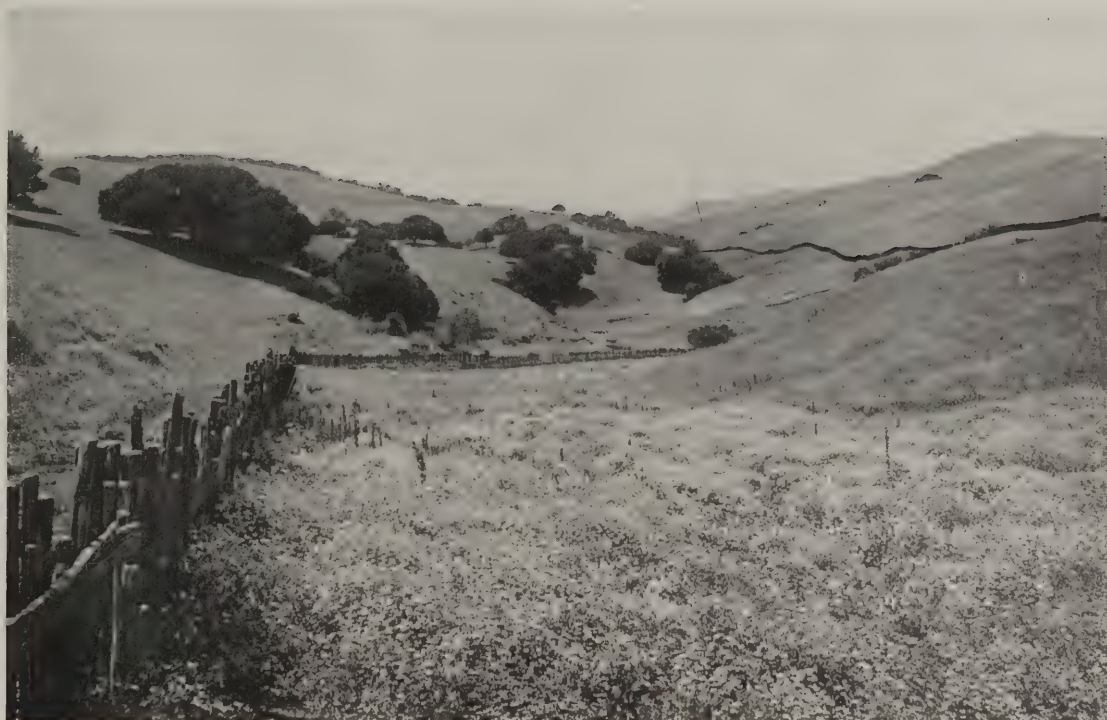
A. Looking northwest along the Rift 3 miles southeast of Chittenden. H. W. F.

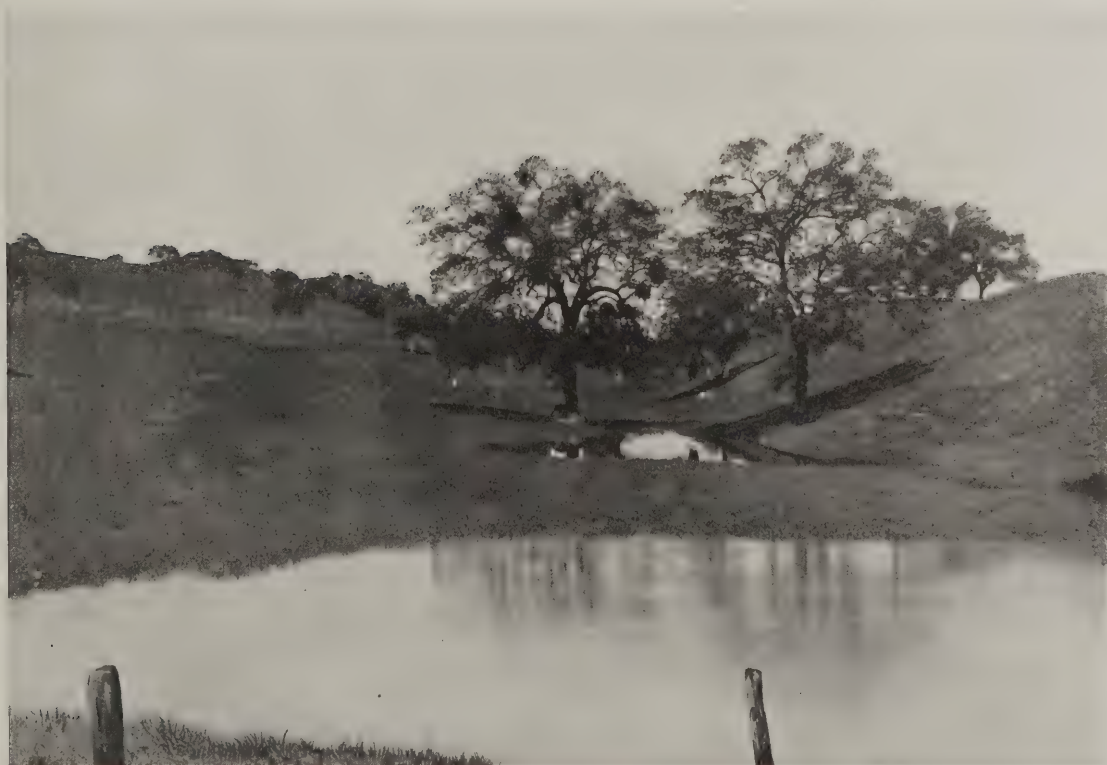
B. Ponds along Rift near San Benito. H. W. F.

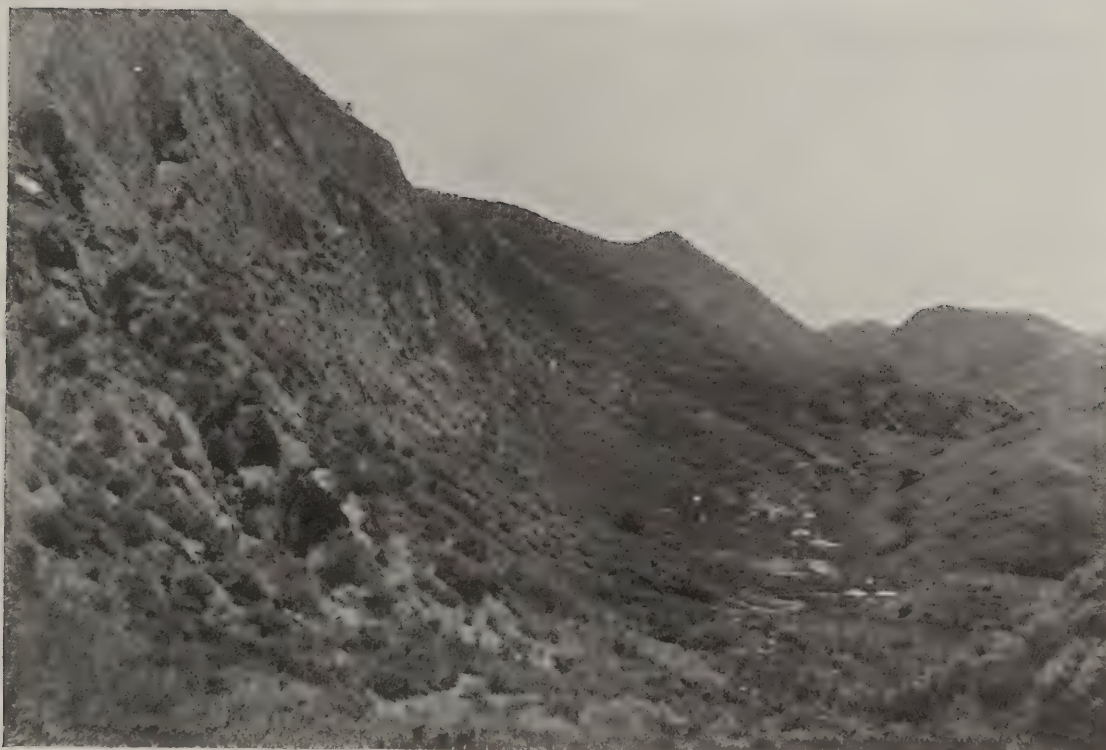
A. The Rift 2 miles south of Dry Lake Valley, San Benito County. H. W. F.

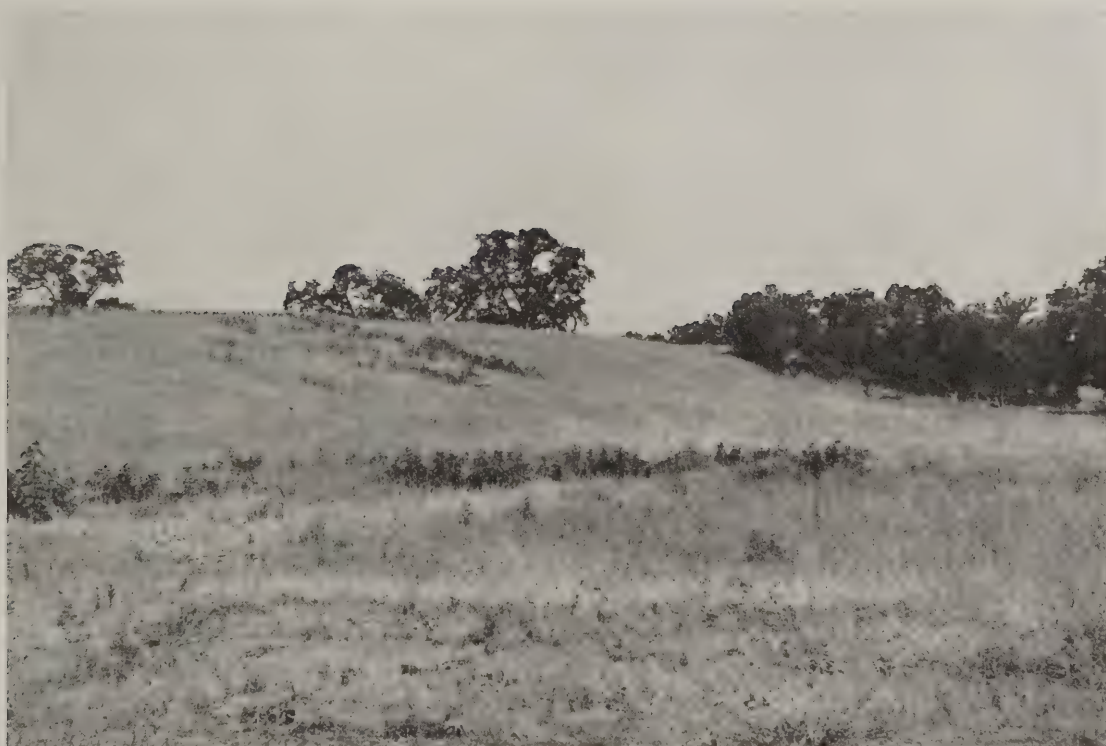
The Rift can be traced thru the hills at the head of the Cholame Valley by its characteristic features, as well as by bluffs which are undergoing rapid erosion. It crosses the road a mile west of Parkfield and exhibits here a regularly rounded ridge 200 feet wide and 20 feet high at the most elevated point. (Plate 19B.) That the ridge must be hundreds of years old is shown by the great oak trees that are growing upon it. One white oak is fully 8 feet thru. Large springs mark the fissure at this point, and are found along it the whole length of the Cholame Valley. According to a resident, the Rift opened along the ridge in the earthquake of 1901, the opening being distinctly traceable for several miles. Southeasterly from the point just described thru the Cholame Valley, there appears no very prominent ridge or escarpment, altho springs and cienegas, marking a gentle swell in the flat open surface of the valley, indicate the line of the Rift.

B. Ancient scarp on the line of the Rift a mile west of Parkfield, Cholame Valley. H. W. F.

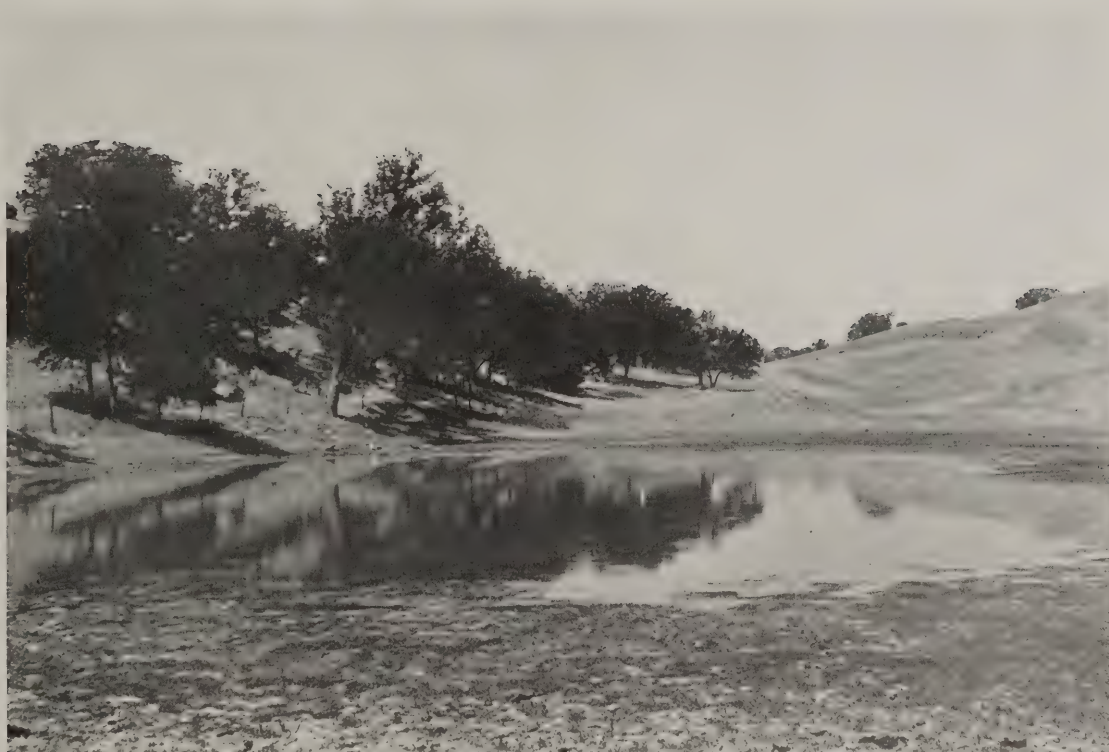
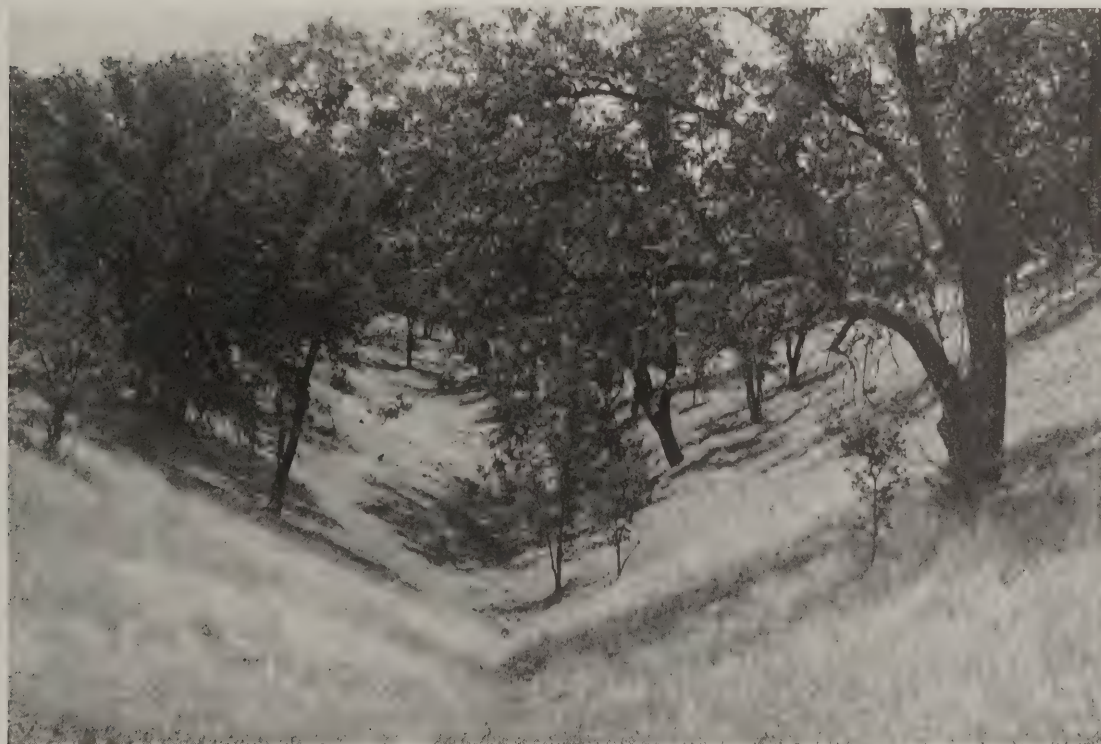
A. A branch of the Rift 2 miles southeast of Parkfield, Cholame Valley. H. W. F.

B. Another view of the same. H. W. F.

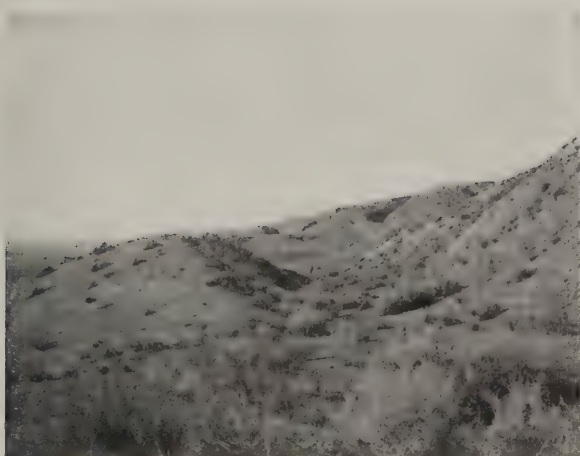
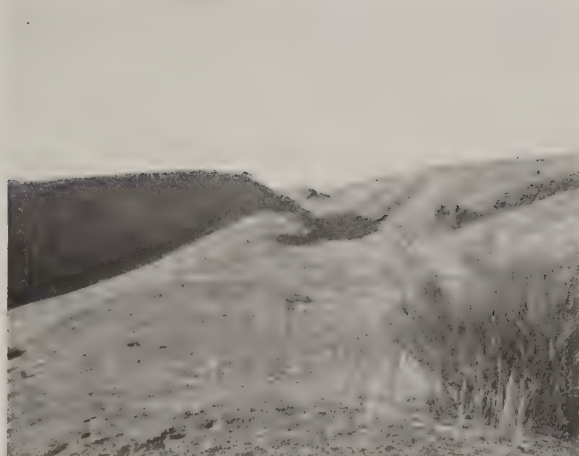
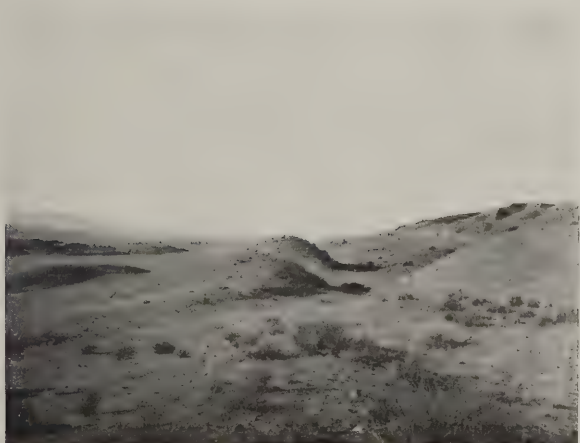
A. Rift, northeast side Carissa Plain. A. C. L., Jan., 1906.

B. Rift, northeast side Carissa Plain. A. C. L., Jan., 1906.

C. Rift, northeast side Carissa Plain. A. C. L., Jan., 1906.
